# The unusual journey of a retained epicardial pacing wire

## ABSTRACT

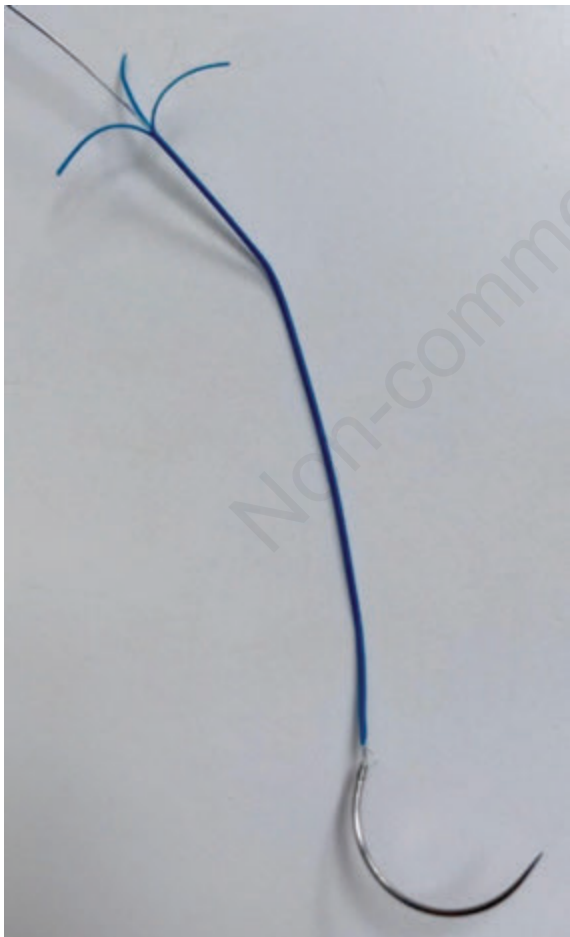
**Figure 1.** Myopace (FIAB Spa) epimyocardial electrodes are usually applied on the right atrium and right ventricle at the end of cardiac surgery, for postoperative rescue external pacing.

A 68-year-old Caucasian man was admitted to our Institute for worsening heart failure. His medical history included arterial hypertension, dyslipidemia, chronic obstructive pulmonary disease and hypothyroidism. The patient had an anterior ST-elevation myocardial infarction and underwent a primary percutaneous coronary intervention + drug-eluting stents on proximal left anterior descending artery. Subsequently he showed an unfavorable left ventricular (LV) remodeling leading to a dilated cardiomyopathy with apical aneurism, reduced left ventricle systolic function (28%), functional severe mitral and tricuspid regurgitation. Six months later, the patient underwent double coronary artery bypass grafting, mitral annuloplasty, tricuspid annuloplasty with Carpentier's annulus and left ventricular surgical restoration. During open-heart surgery two epicardial wires [Myopace; FIAB Spa, Vicchio (FI), Italy] were applied on the right atrium and right ventricle respectively, for postoperative rescue external pacing (Figure 1). Due to an

to the myocardium through a suture. Wires stability can be ensured by a single stitch in the outlet point of the thoracic wall to avoid the dislocation of the electrode by accidental tractions. Conventionally, the ventricular EPW is exteriorized left and the atrial one right. Usually for EPW removal a light traction allows the complete extraction of the wire. To prevent tissue reaction producing bridles interfering with EPW removal, extraction should be carried out as soon as the electrostimulation is no longer required and, in any case, within 20 days from implantation.
